SBS Back Tracker $50 \times 50 \text{ cm}^2$ Triple GEM proto1

HV test procedure

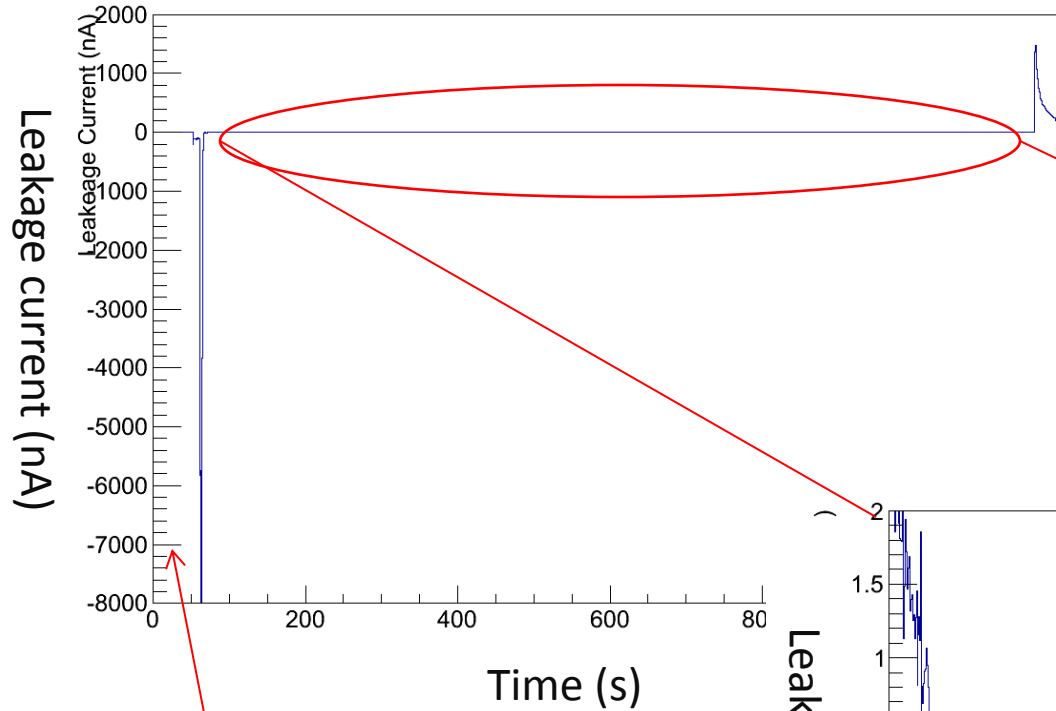
testFramedFoil4Sector16

HV test of Sector16 from GEM2

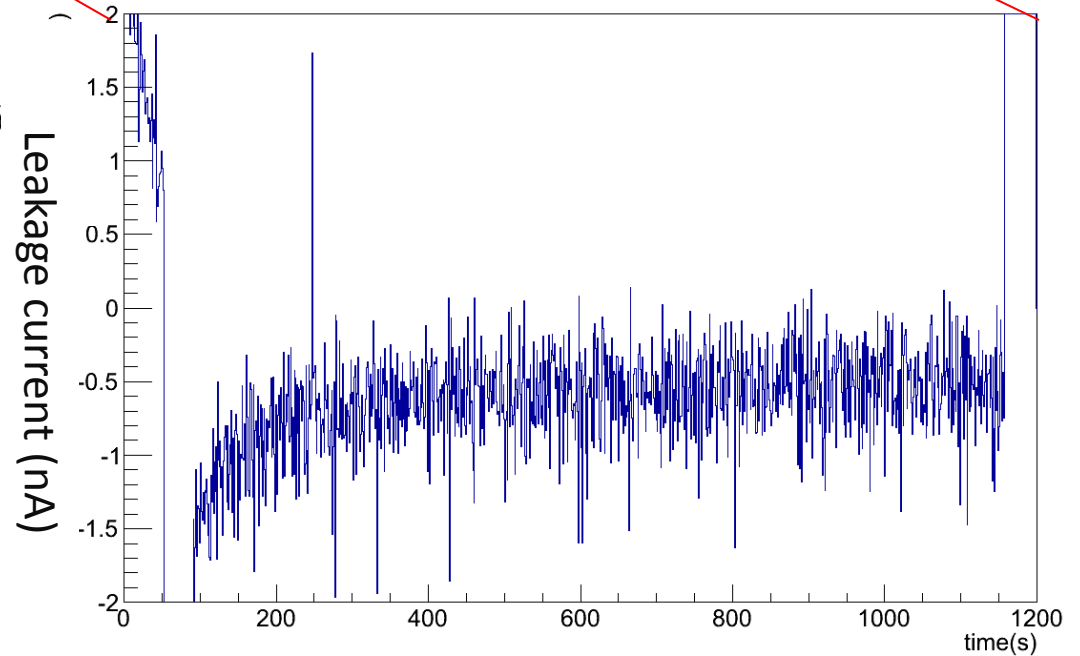
testFramedFoil4Sector16

- A GEM sector has a capacitance of approximately 2 nF; and the resistance engaged in the HV module is $\sim 50 \text{ M}\Omega$, once the stable voltage is achieved this resistance is shunted automatically within the supply). As a result, when we are setting the required high voltage of 550 V, the initial current is a couple of μA , then quickly drops and stabilizes to about less 1 nA leakage current far better than the 5 nA requirement.

Initial current when
applying the HV

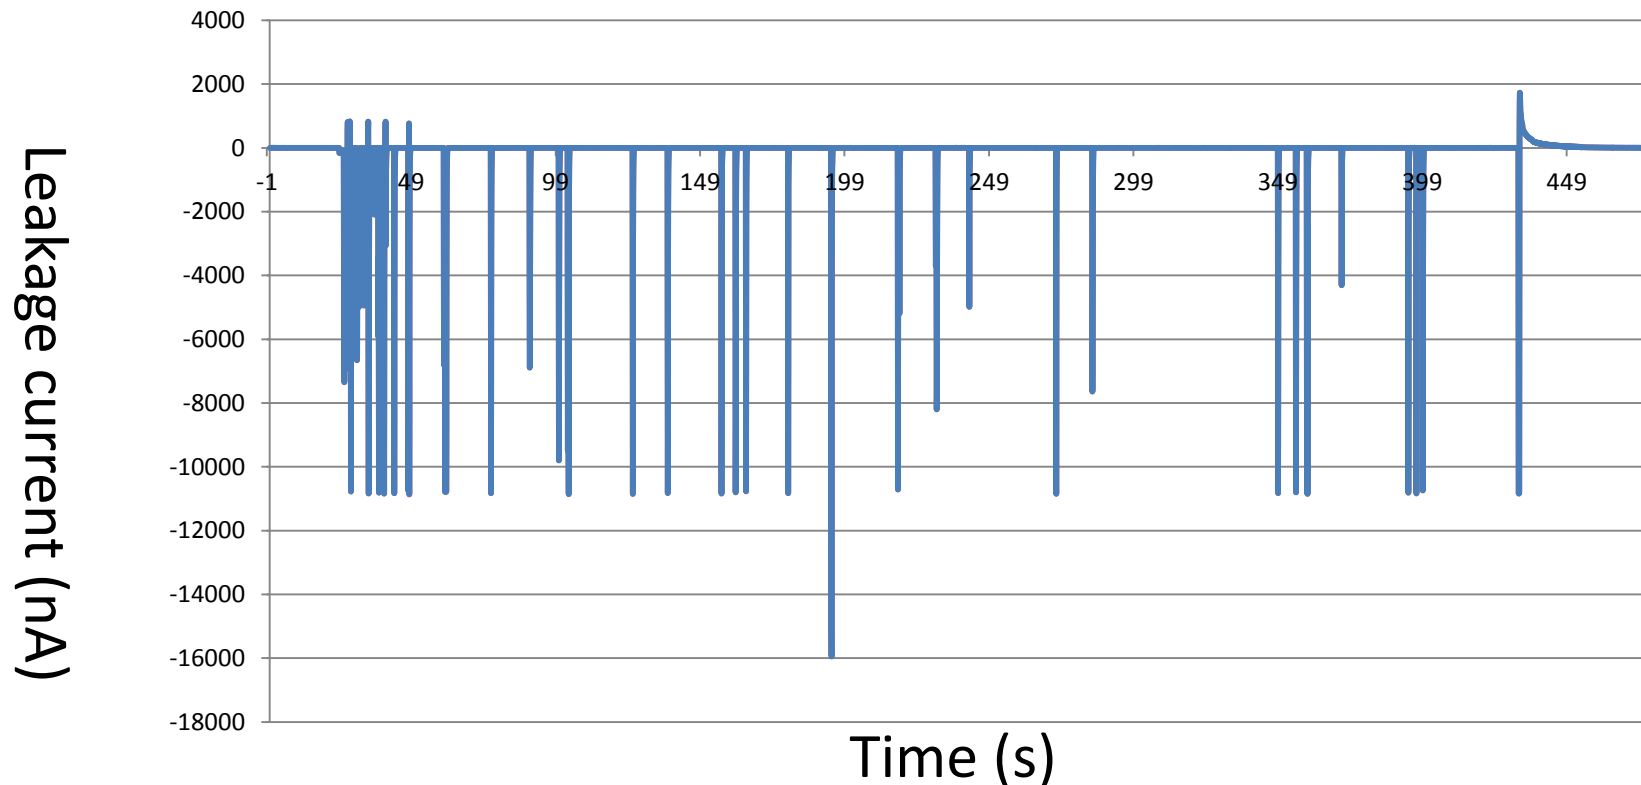
Spark rate and amplitude on a dirty foil

- We tested the HV test procedure using a small 10 cm x10 cm GEM foil in the N2 box.
- Before the test, it was allowed to collect dust for 10 minutes outside the clean room.
- Series of current spikes corresponding to sparks in the GEM foil arising from dust particles burning.
 - The spike lasts a couple of hundred ms and current up 15 μA . Sparks are visible and audible.
 - After the spark the current goes down to ~ 1 nA level with no burn marks in the foil afterwards.
 - The spark rate decreases with time and the current stable at < 1 nA.

- **Do not** ramp up the HV slowly from 0 to 550 to test the foil instead one should directly apply the nominal test HV
 - ➔ See Rui's talk for explanation
- Limitation of the current should be set high enough to avoid trip and allow burning of the dust on the foil
 - ➔ In our case we set it at 15 μA
 - ➔ A trip of the HV power supply can be as bad as ramping the HV slowly
- When a sector has a lot of sparks and do not stabilize with 20 s ➔ stop the HV and let it dry under N₂ for a couple of days
 - ➔ If the problem persists, send the foil back to Rui

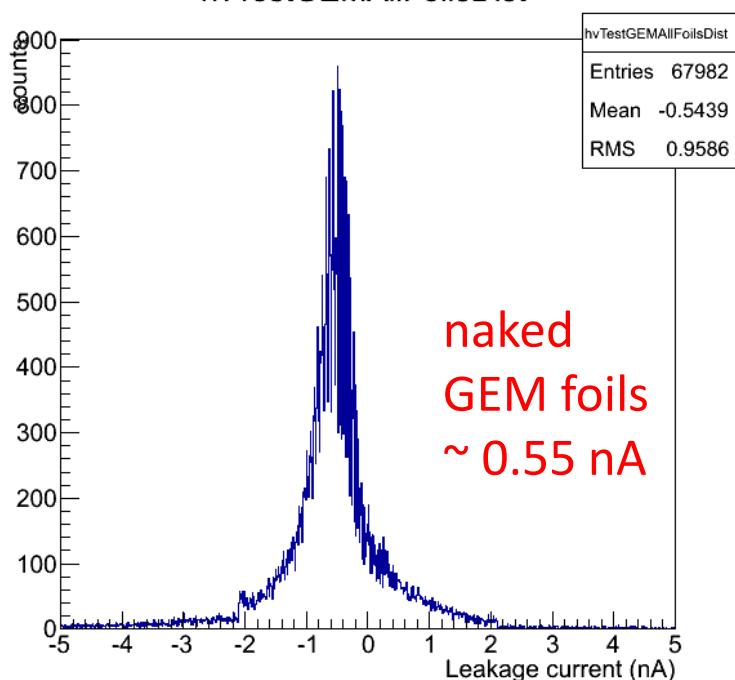
hvTestGEMAllFoilsDist

- Distribution of leakage current over all the 72 sectors
- 24 sectors per foil → 3 foils → 72 sectors
- HV test at 550 V under N2 for naked, framed foils and in chamber foils

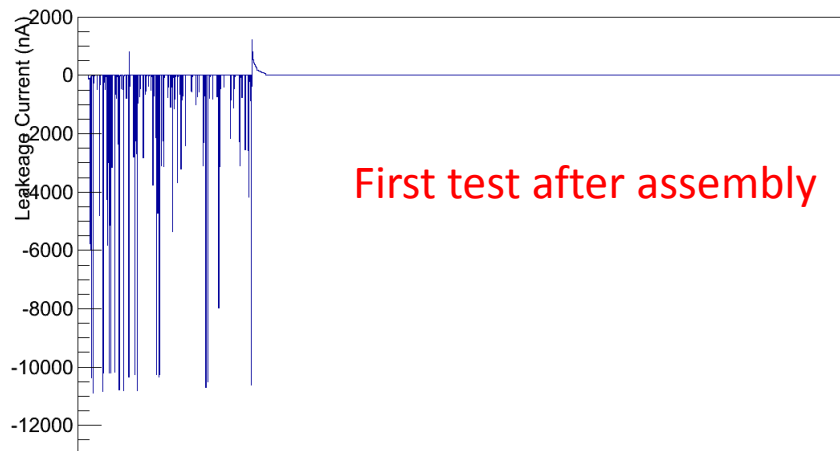
hvTestSBSPProto1Foil2Sector12

Curing of the sector12 on GEM1

Excess of glue leaked onto the sector during assembly → sector can be recovered
after curing on N₂ or at 50 degree
